STAR ONLINE PUBLICATION

Case Number: S2108000074

Symptom/Vehicle Issue: Wiring Harness Contacts Drivers Catalytic Converter. Check Engine Light (CEL), Anti-Lock Brake System (ABS), Traction Control System (TCS), Service 4WD Lamp On

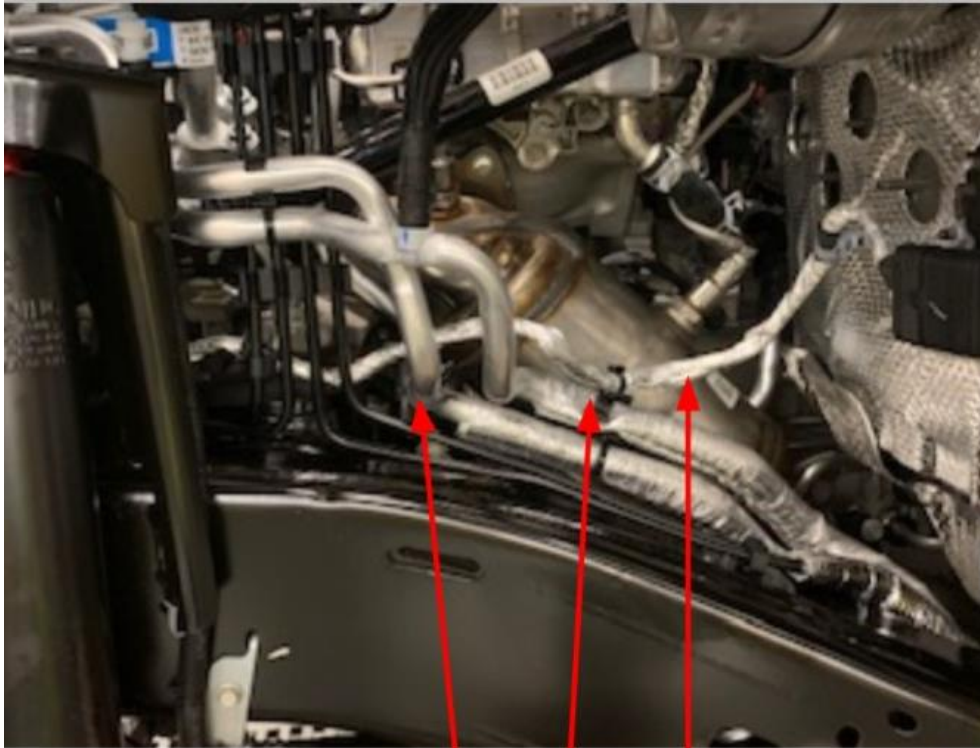
Discussion: Due to incorrect routing, the wiring harness that runs down the drivers frame rail, known as the “Left Chassis Harness” may make contact with the catalytic converter. The Check Engine Light, ABS, Traction Control and Service 4WD lamps may be illuminated. Upon scanning the vehicle for DTC’s you may find one or more of the following: C0031, U0102, U0418, U0037, U1003, C1416

Current design, C clips - bundle route between tubes and exhaust. C clip slide down, create extra length, make bundle closer to exhaust.

Repair: Using standard repair methods. Repair any damage to the wiring harness caused by contact with the exhaust system. Next, Disconnect the XY290A inline connector so the harness can be rerouted away from the exhaust system.

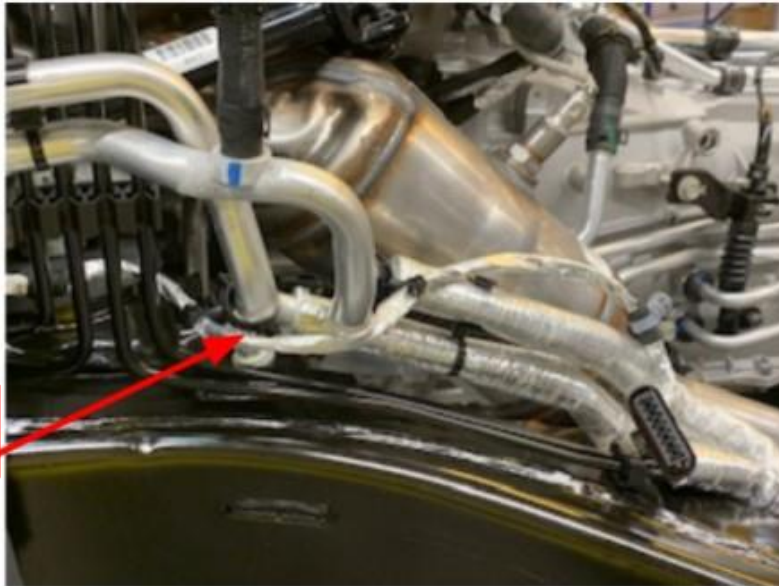
Corrected routing of left chassis harness underneath coolant tubes.

Reroute the harness so that it is positioned underneath the coolant tubes and away from the exhaust as seen below. The two clips that secure the harness to the coolant tube need to be relocated and flipped. Reference the image below as a guide.
