NUMBER: 09-010-20

Engine Oil Vapor Inlet Tube Modification - P2173-00 - Air Leakage In Manifold (Signal Compare Failure)

2017 - 2018 (BU) Jeep Renegade

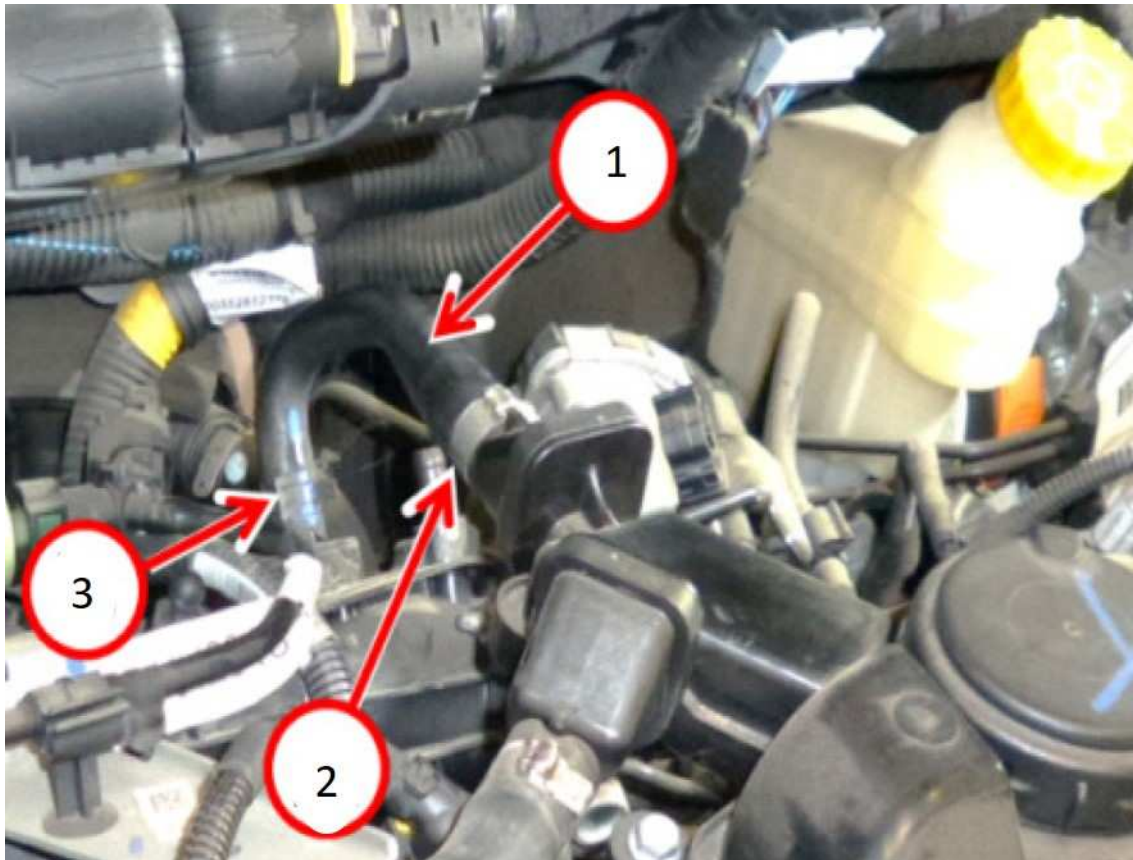
Fig. 1
Oil Vapor Inlet Tube

- 1 - Oil Vapor Inlet Tube
- 2 - Clamp to be Discarded Do Not Reuse
- 3 - Clamp to be Reused Do Not Discard

1. Remove the engine cover. Refer to the detailed service procedures available in DealerCONNECT> Service Library under: Service Info> 09 - Engine, 1.4L I4 16V Turbo / Cover, Engine / Removal.
2. Remove the clamps, then remove the oil vapor inlet tube (Fig. 1) .

NOTE: The clamp at the vapor separator and tube can be discarded; the clamp at the engine must be kept and reused for reassembly (Fig. 1) .

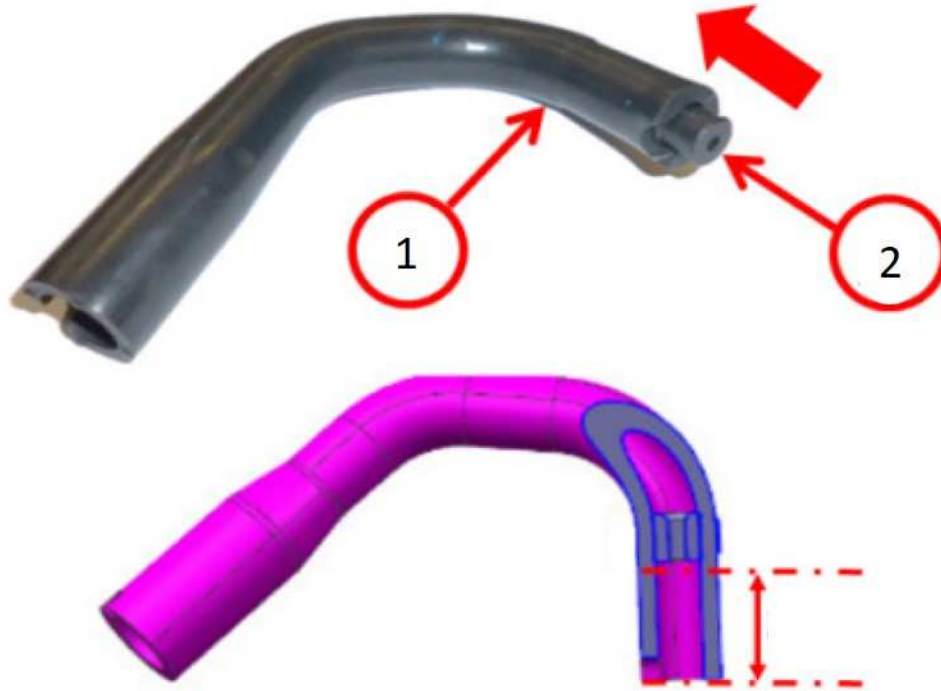
Fig. 2
Oil Vapor Restrictor

- 1 - Oil Vapor Tube
 - 2 - Restrictor
-

3. Insert the restrictor with larger hole into the tube, making sure that the side with the smaller hole is towards the connector on the intake air chamber (Fig. 2) . Take great care when inserting the restrictor into the tube.
4. The restrictor must be inserted into the tube to a depth of 26-27 mm (1 in) (Fig. 2) .
5. The side with the smaller hole must be towards the intake air chamber and the side with the larger hole must be towards the oil vapor separator (Fig. 2) .
6. The restrictor must then be clamped in position with a band, and the insulating sheath must be fixed to the tube as described below (Fig. 2) .

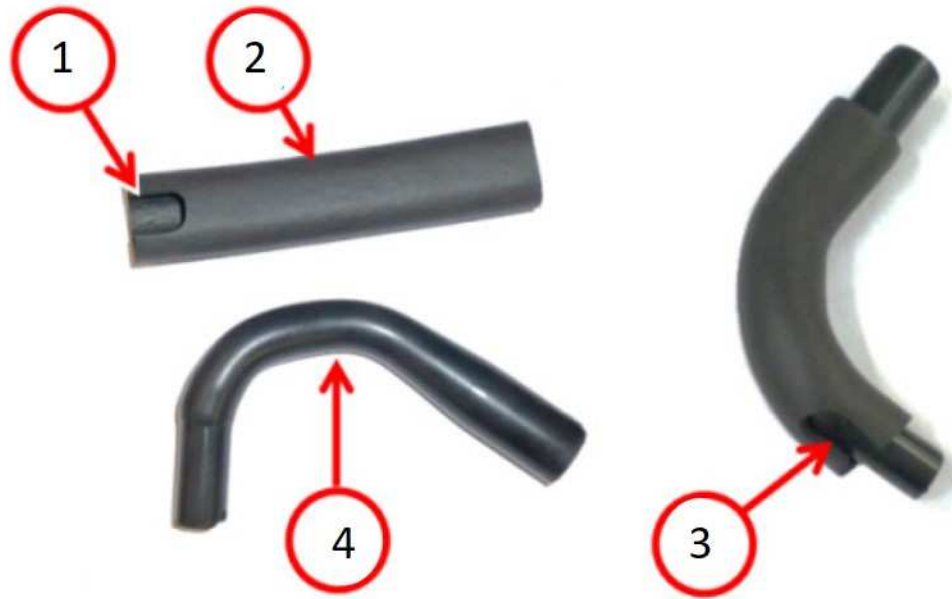
Fig. 3
Oil Vapor Sheath

- 1 - Clamp Opening in the Sheath
 - 2 - Sheath
 - 3 - Sheath Installed with Clamp Opening Hole
 - 4 - Oil Vapor Inlet Tube
-

7. Install the insulating sheath over the tube so that the opening is at the restrictor inserted previously (Fig. 3).

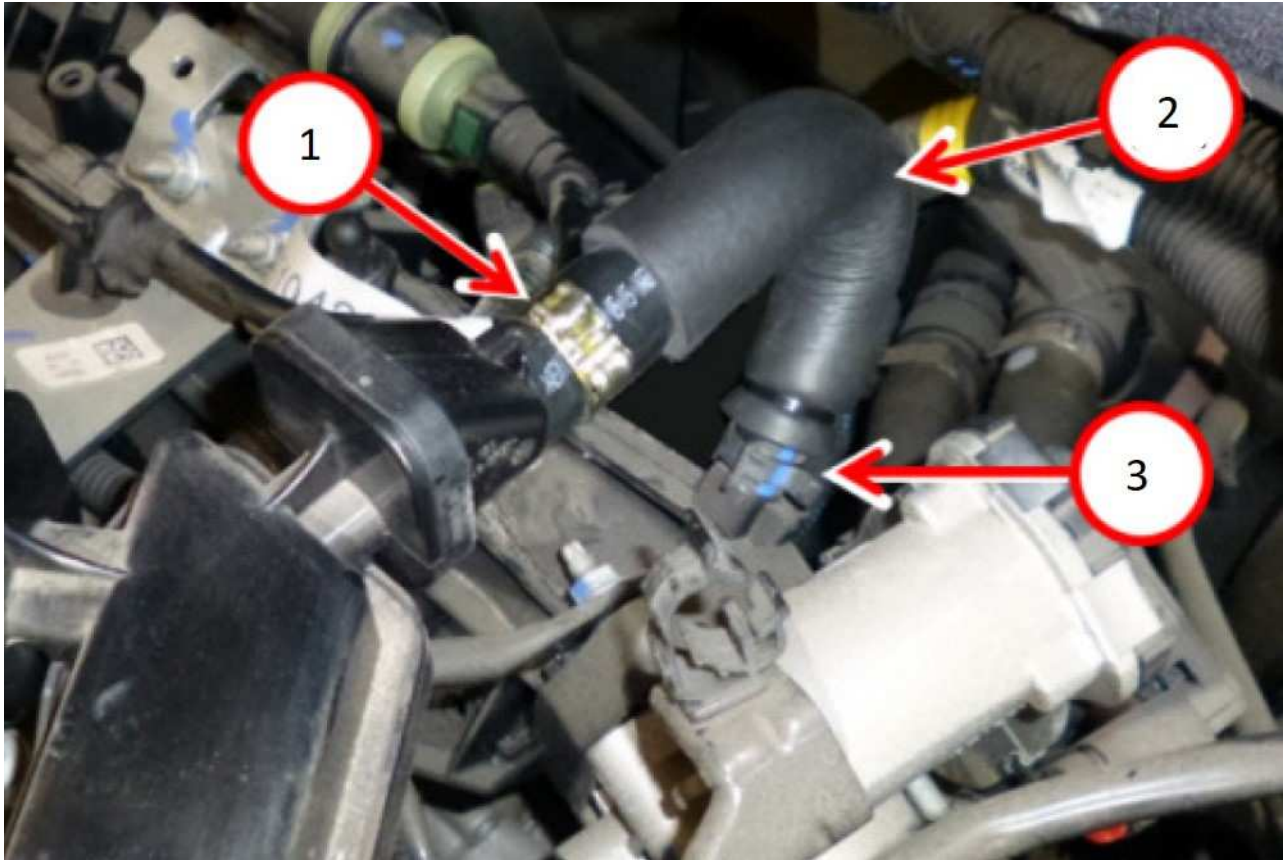
Fig. 5
Oil Vapor Inlet Tube

- 1 - New Clamp at the Vapor Separator
- 2 - Oil Vapor Inlet Tube
- 3 - Clamp to be Reused at the Engine

9. Install the new engine oil vapor inlet tube with restrictor as follows (Fig. 5) :
 - a. Install the tube to the intake air chamber and secure it with the clamp that was previously removed and saved (Fig. 5) .
 - b. Install the tube to the oil vapor separator and secure it with the new clamp (Fig. 5) .
